Total Land Subsidence in the Hawk Rock Area, Maricopa and Pinal Counties
Based on ERS-1 and 2 Satellite Interferometric Synthetic Aperture Radar (InSAR) Data
Time Period of Analysis: 8.0 Years 05/17/1992 To 04/19/2000

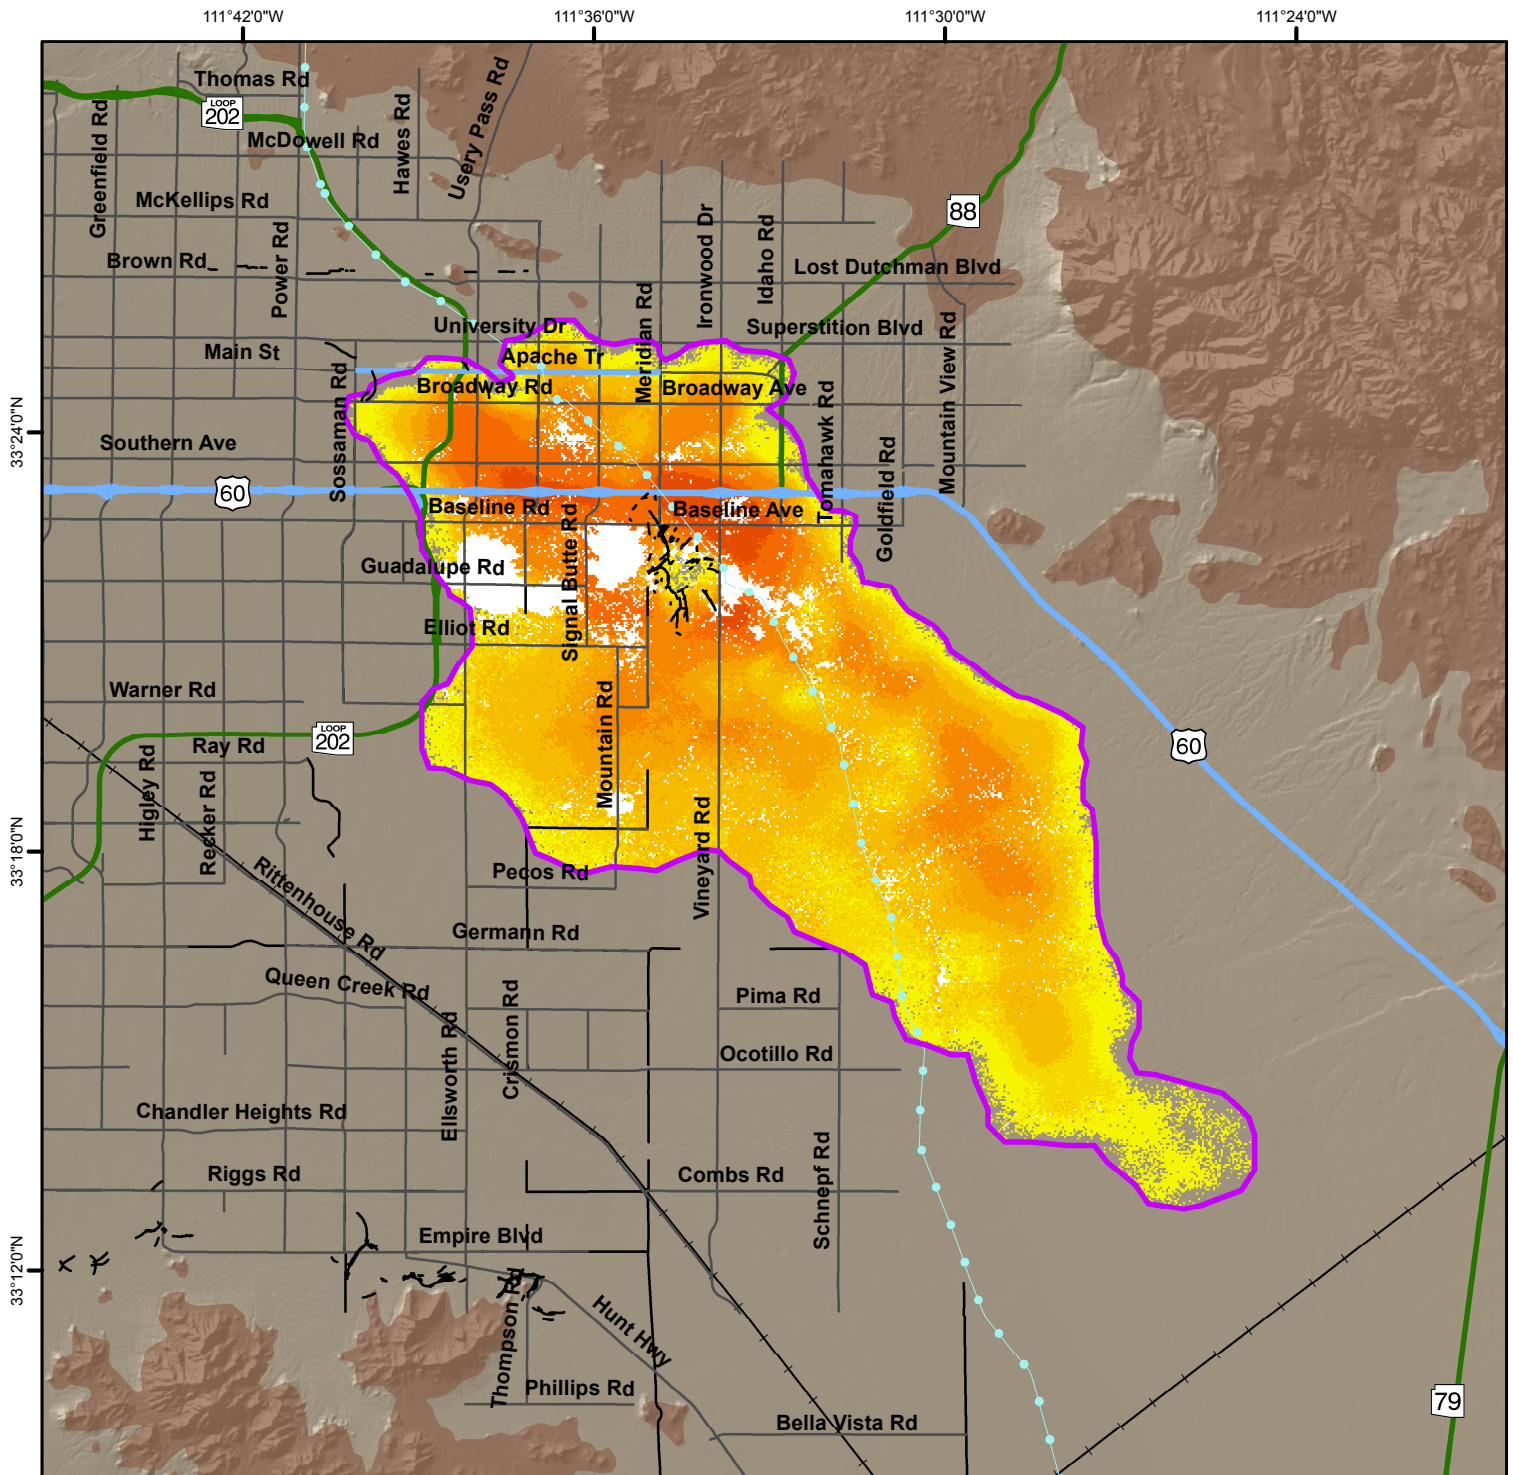
Decorrelation (white areas) are areas where the phase of the received satellite signal changed between satellite passes, causing the data to be unusable. This occurs in areas where the land surface has been disturbed (i.e. bodies of water, snow, agriculture areas, areas of development, etc).

Earth fissures were mapped by the Arizona Geological Survey.
 For information on earth fissures visit: www.azgs.az.gov/EFC
